PASSAIC RIVER BASIN

NEW STREET RESERVOIR DAM

PHASE I INSPECTION REPORT
NATIONAL DAM SAFETY PROGRAM

Name of Dam: New Street Reservoir Dam, I.D. NJ00242
State Located: New Jersey
County Located: Passaic
Stream: Slippery Rock Brook
Date of Inspection: June 30, and July 7, 1978

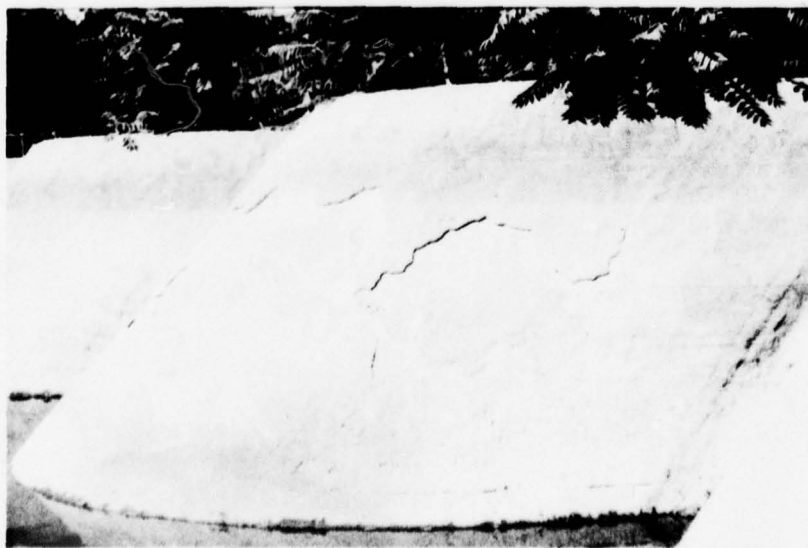
All construction joints appeared to be tight. No serious structural cracking was observed, however, numerous small cracks were visible in many of the arches, the majority occurring between 5 to 15 feet from the crest. Most noticeable was the leaching which has occurred through the concrete. In some arches the deposits were quite sizeable. No water was observed flowing from any of the cracks or joints. The gunite coating on the upstream face was in good condition with only some minor spalling on arches near the right abutment.

Photo 2 - View of spalled gunite on upstream surface of dam.

VISUAL EXAMINATION OF	OBSERVATIONS	REMARKS OR RECOMMENDATIONS
SURFACE CRACKS CONCRETE SURFACES	Gunite coating in good condition on upstream facing. Some minor spalling on arches near right abutment.	Spalled gunite should be repaired. See notes under leakage.
STRUCTURAL CRACKING	See notes on attached sheet.	
VERTICAL AND HORIZONTAL ALIGNMENT	No evidence of movement of the structure could be found.	
MONOLITH JOINTS	The joints between arches not visible for inspection but gunite facing does not indicate movement or separation.	
CONSTRUCTION JOINTS	Construction joints between buttress cap beams and shells are all tight and show no evidence of movement or distress. No evidence of rust stains can be found on the concrete surfaces except beneath the ships ladder and metal platform.

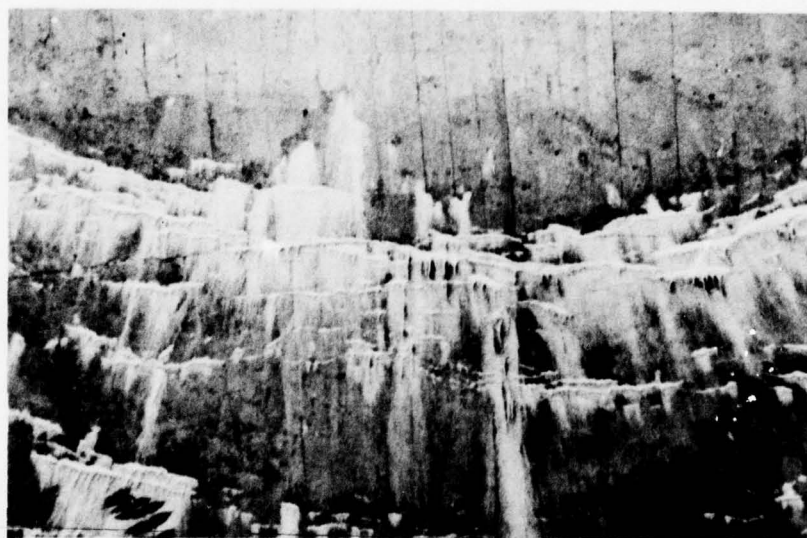
Photo 7 - Leach deposits near top of arch slab.

2. The upstream face of the dam should be waterproofed by application of gunnite, chemicals, or membrane coatings to prevent leakage and possible further leaching of concrete in arch shells. Chemical analysis of the leach deposits should be made to determine if they are formed from concrete leaching or dissolved chemicals in the water.

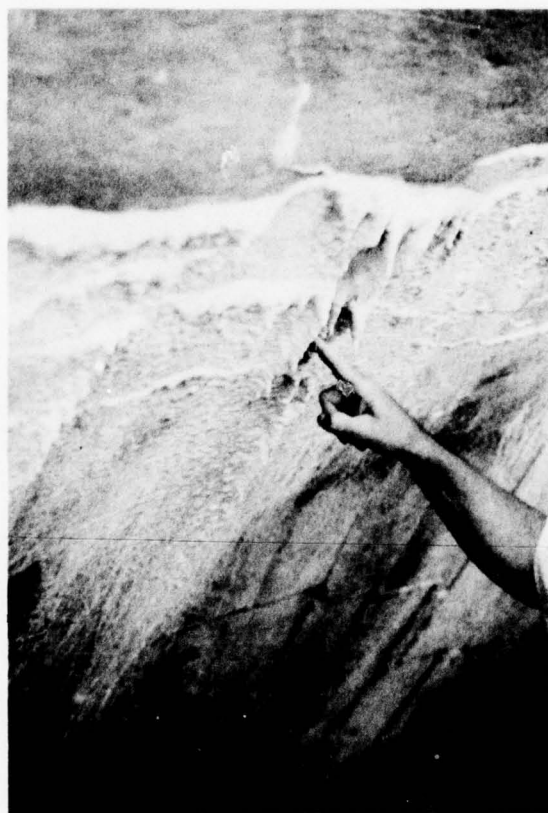
Photo 9 - Close-up view of leach deposits.

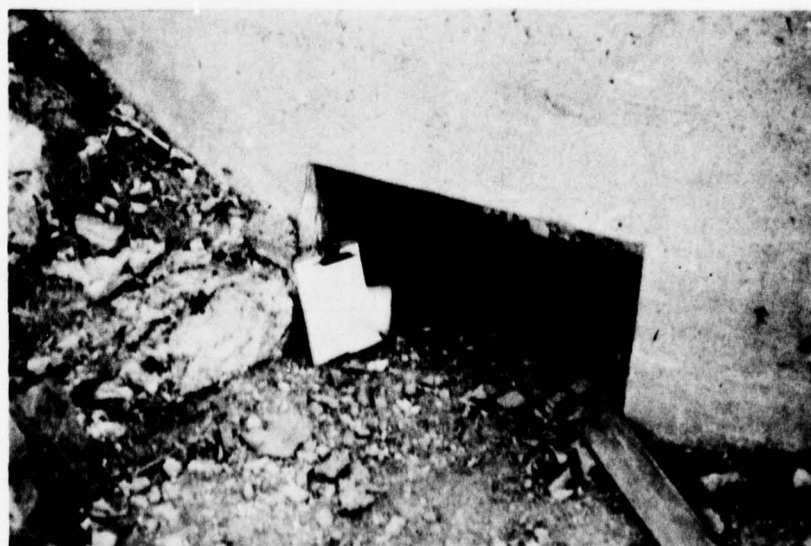
The spillway was in excellent condition with no signs of cracking or spalling. The 2 foot by 3 foot rectangular outlet conduit appeared to be free of debris. All stoplogs were in place at the time of the inspection. One dead tree was down on the right abutment slope which constitutes the spillway approach, and threatens to block the spillway. A cluster of 6-inch diameter trees stand 6 to 7 feet downstream of the outlet. No erosion protection exists between the rectangular outlet and the diversion ditch.

Photo 10 - View of spillway outlet opening.

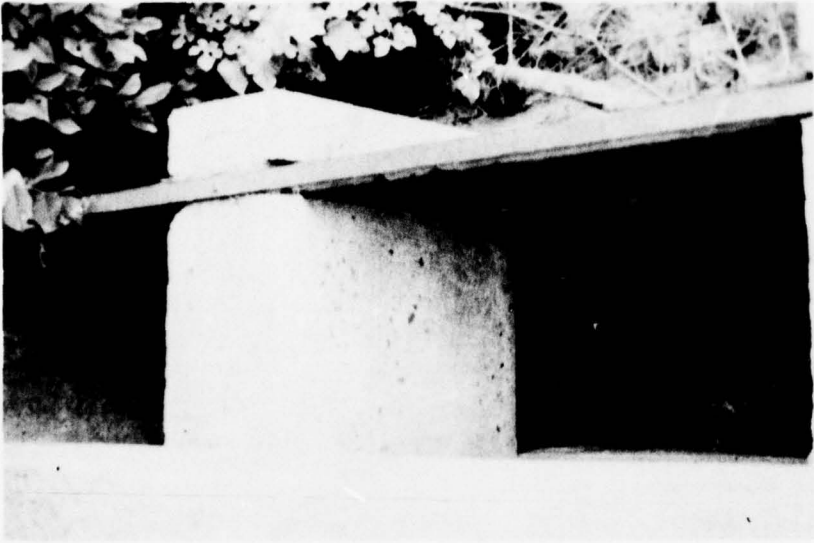
Photo 12 - View of stop boards in spillway box.

A temporary alternative would be to remove some of the stoplogs presently in the spillway. A sufficient number of boards would have to be removed so that spillway discharge could not be exceeded by pumping from the Little Falls Pump Station.
